Johnson, R.M. and Warburton, J. (2015) 'Sediment erosion dynamics of a gullied debris slide : a medium-term record.', *Catena*, 127 . pp. 152-169.

Title: Sediment erosion dynamics of a gullied debris slide: a medium-term record

Keywords: headwater catchment; debris slide; medium-term sediment dynamics; erosion; gully development; meteorological conditions.

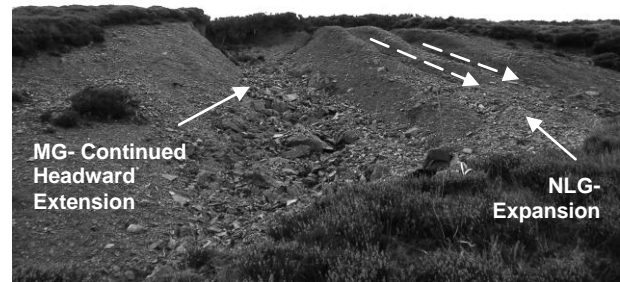
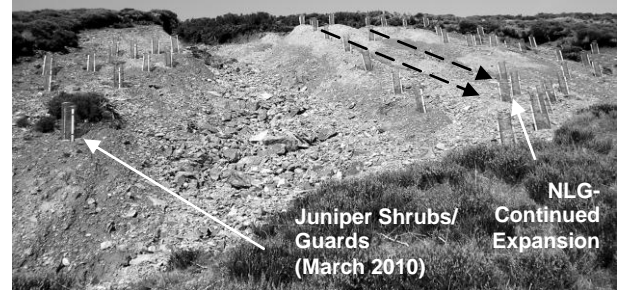
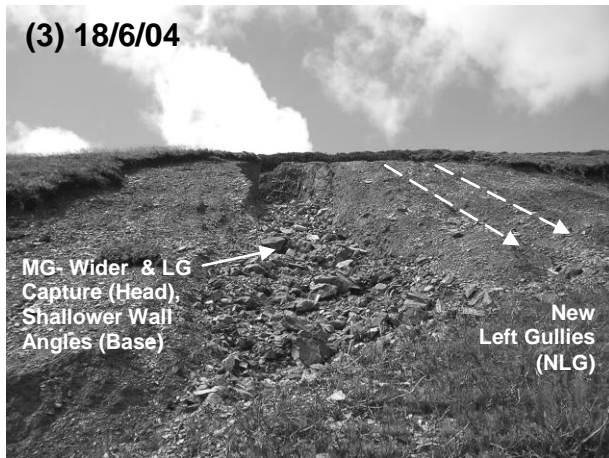
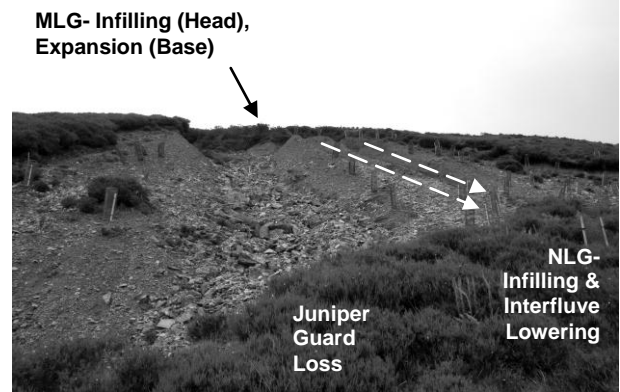
Fig 3

18  
19 Post-failure activity beyond the main gully was initially less marked, but became  
20 more prominent by 2008. The 'left gullies' (Figure 3) can be grouped into two  
21 sets, firstly shallow forms which existed prior to June 2004 and were captured  
22 by the widening of the main gully and; secondly, two gullies which developed  
23 nearer the scar edge ('new left gullies' in Figure 3), fed by runoff from the upper  
24 hillslope. By March 2008 these gullies transferred sediment beyond the scar

1 perimeter, with coarse sediment eventually coupling with Wet Swine Gill (first  
2 observed in July 2012). Furthermore, ongoing interfluvial lowering between them  
3 (Figures 3 and 4), may in time result in the capture of gully L1 by gully L2.  
4 These may also eventually merge with the main gully, triggering a new phase of  
5 activity.

1 communication). Figure 3 (photos 7 & 8) shows subsequent widespread loss/  
2 tilting of the plastic nursery guards installed around the Juniper shrubs. By 30  
3 July 2014, 39% of nursery guards had failed and only 30% of the planted  
4 shrubs were established. Furthermore, following February 2014, under a 2013  
5 Higher Level Stewardship Agreement, the Caldbeck Commoners Association,  
6 LDNPA and Natural England, have planted 500 native trees on hillslopes  
7 adjacent to the Wet Swine Gill stream, with 64 immediately downslope of the  
8 scar (Barron, 2014, personal communication; Planning Inspectorate, 2014).  
9 Additional works are planned for later in 2014, including a temporary fence  
10 enclosure (consented for 15 years) around the failure scar (Barron, 2014,  
11 personal communication); this is part of a wider initiative in the Caldbeck Fells  
12 to reduce sediment transfer and improve water quality (Planning Inspectorate,

communication). Figure 3 (photos 7 & 8) shows subsequent widespread loss/tilting of the plastic nursery guards installed around the Juniper shrubs. By 30 July 2014, 39% of nursery guards had failed and only 30% of the planted shrubs were established. Furthermore, following February 2014, under a 2013 Higher Level Stewardship Agreement, the Caldbeck Commoners Association, LDNPA and Natural England, have planted 500 native trees on hillslopes adjacent to the Wet Swine Gill stream, with 64 immediately downslope of the scar (Barron, 2014, personal communication; Planning Inspectorate, 2014). Additional works are planned for later in 2014, including a temporary fence enclosure (consented for 15 years) around the failure scar (Barron, 2014, personal communication); this is part of a wider initiative in the Caldbeck Fells to reduce sediment transfer and improve water quality (Planning Inspectorate, 2014).
